Assessment of Institutional Library R.C.C Building in Ahmedabad

In Ahmedabad a premier institution LD College of Engineering library building was assessed in the year 2019. The distress observed in the building is classified into structural and non-structural elements. In structural element different types of cracks, spalling and corrosion and non-structural element distress like crack, dampness, staining and peeling of paints were observed. Some of the major reasons for distress in the structure are ageing, environmental effect, inadequate maintenance, change in load pattern and leakage of water and sewage lines.

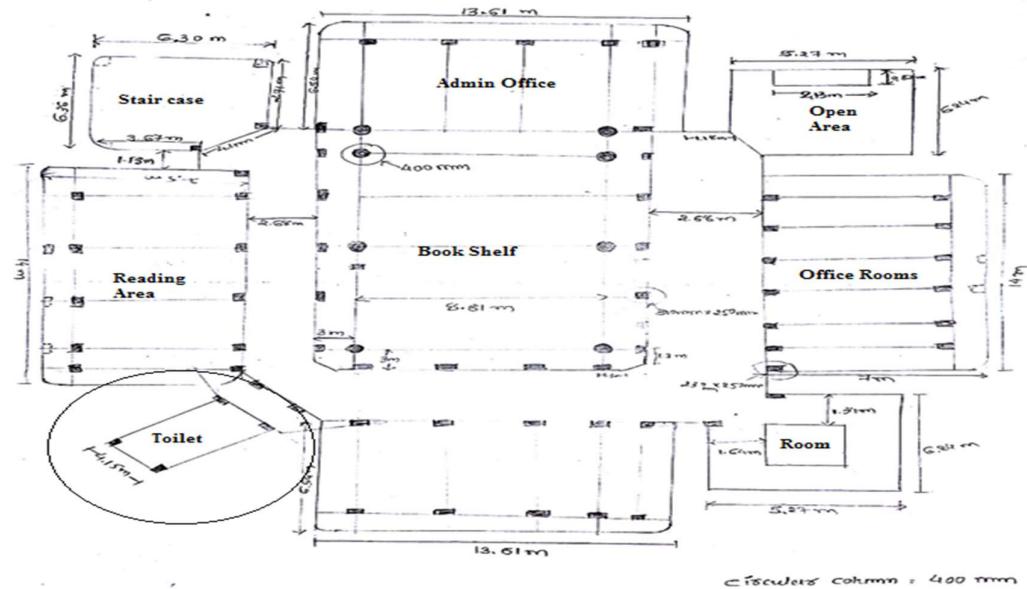
Fig.1. Plan of Library Building

The Plan of library building is shown in fig. 1. The major distress was observed in the toilet block area on the first floor (as shown in the highlighted circular area) and in the space directly below it on the ground floor, which was allotted as a store room. The highlighted zone had remained unused for several months.

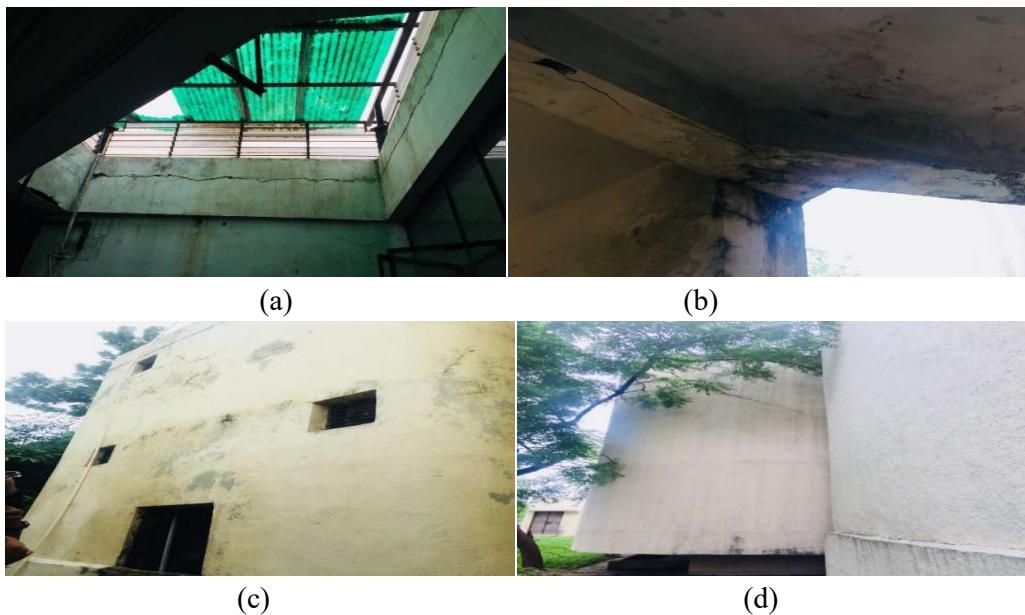
Visual inspection for Library building was carried out. If a building has given about 25 to 30 years of service without much maintenance or repair then it is reasonable to expect that it would need some repair sooner or later. The different types of cracks observed in the structure are bonding cracks, shrinkage cracks, diagonal cracks and longitudinal cracks. The

measured crack wide was >2mm.

Fig.3 Different Cracks (a) bonding crack (b) longitudinal crack (c) shrinkage crack (d) diagonal crack

The improper bonding between structural and non-structural element leads to bonding cracks in figure: 3 (a). The longitudinal cracks may be observed in structural element due to insufficient cover of the member in figure: 3 (b). The improper curing and weathering effect the shrinkage cracks develops in figure: 3 (c). Due to varying temperature shrinkage crack occurs which increase in crack leads to diagonal crack in masonry walls figure: 3 (d). Due to ageing the crack in the structure lead to widen up and enlarge if not proper repair treatment are done. The external agencies like physical, chemical or environmental aspects would enter into the cracks and make the distress worse. It also leads to other distress like spalling, staining, corrosion etc.

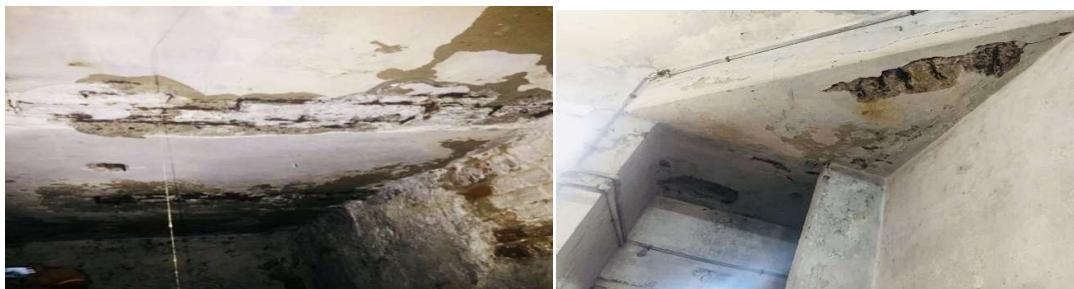
The spalling is observed in slab, reinforcement are observed. Over time, corrosion of the reinforcement begins. The major causes of spalling are insufficient cover, cracks, shrinkage, weathering effects in figure: 4.

Fig.4 Spalling & Corrosion of reinforcement in structural element

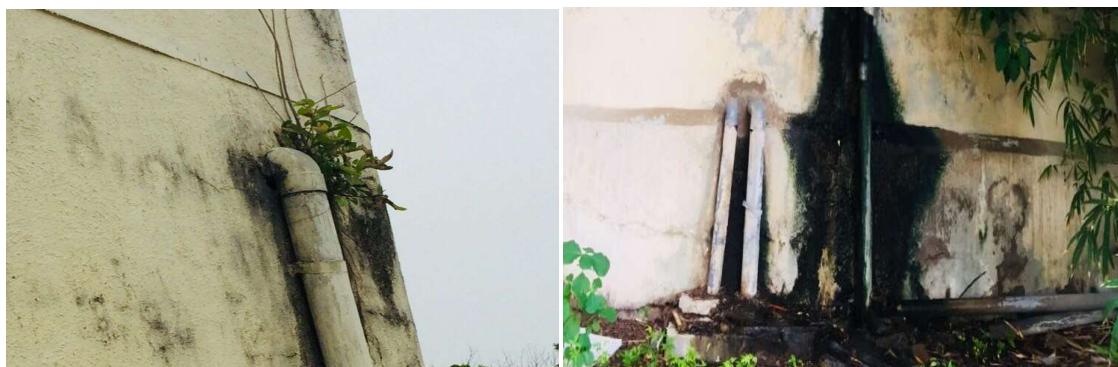
The staining effects are observed in the structure due to leakage of pipelines. The improper sealants in joints leakage of water leads to growth of plants in figure: 5

Fig.5 Staining effects

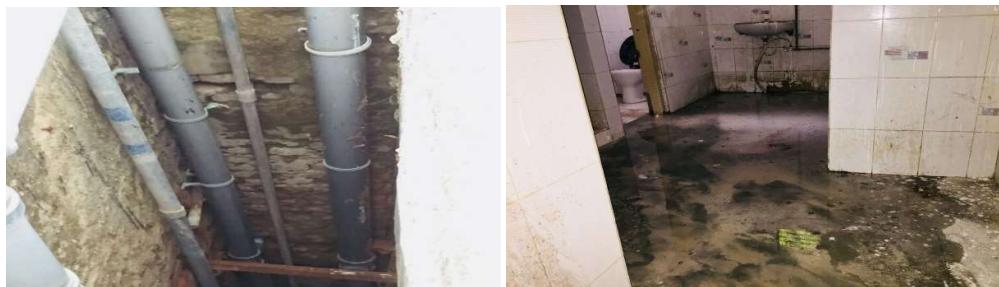
Due to leakage of water and drainage pipelines dampness and peeling of paints in the structure are also observed in figure:6

Fig. 6 Peeling of paints and dampness effects
